PROPERTY INSPECTION REPORT

[REDACTED] Palomino, Frisco, TX 75034

PROPERTY DESCRIPTION: Single family residence, 1865 SF, constructed in 2000

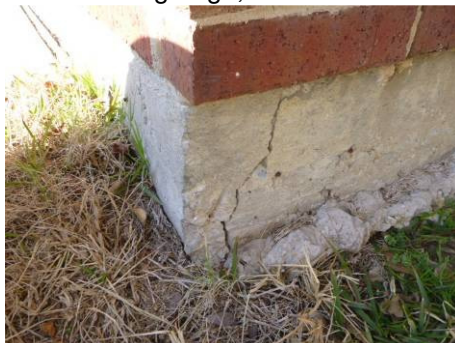
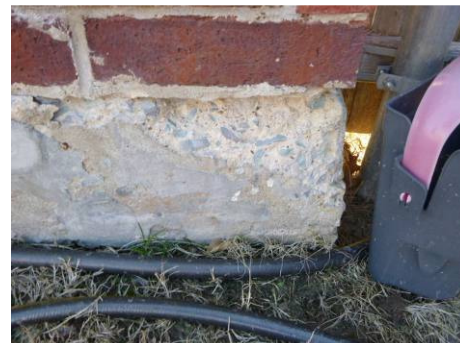
Cracks at foundation corners are common, The cause of this is most often due to thermal expansion of the masonry which applies pressure to the foundation corners causing them to crack and/or release. Suggest seal cracks to minimize further separation and deterioration. These do not necessarily represent a structural support issue but can be location(s) of undetected insect entry. See corners i.e. SW corner of garage, NE corner of the master bath.

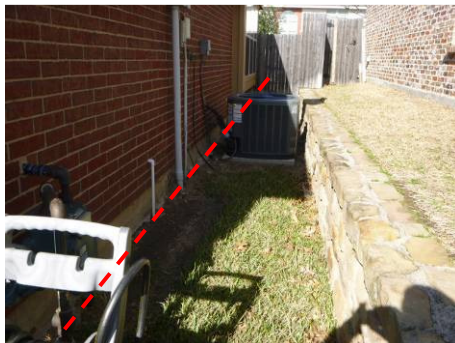
[X] Soil erosion occurring at south elevation earth could be added, there are no gutters to control the roof run-off on this side.

[X] Saturated earth along the south property line, it seems that water from the roof and neighboring lot contribute to excessive moisture. Additionally I recommend to regrade or take the necessary measures so that water drains off of the lot.

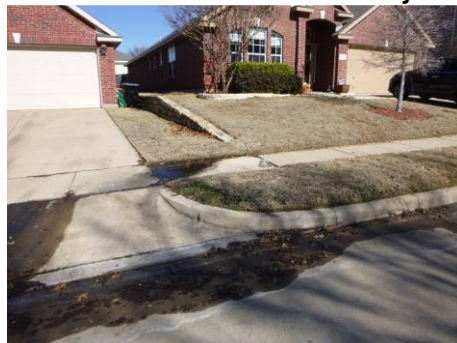
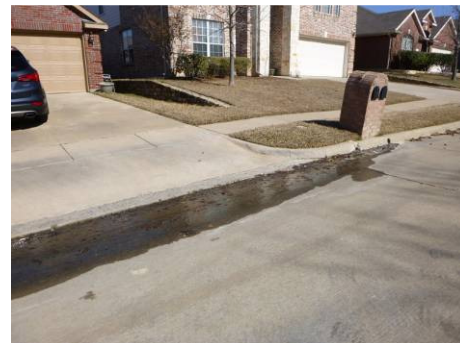
Underground drainage outlet cored through the front curb was observed at the SW and NW corner of the property, ask seller for more information regarding the water inlet (French drain or concealed area drains) and the effectiveness of the system. I do not inspect underground drainage. **AT THIS TIME there is considerable more water flowing from the corners of the lot compared to the neighboring homes on the same side of the street. Advise further review to determine the source of the water and remedy if there is one.**

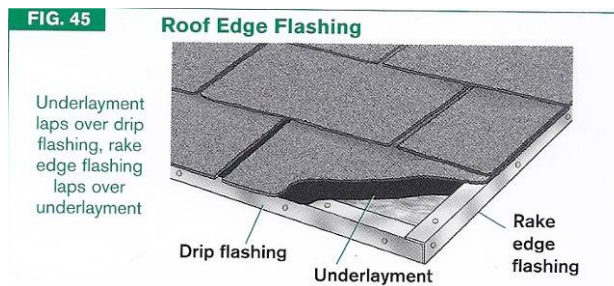
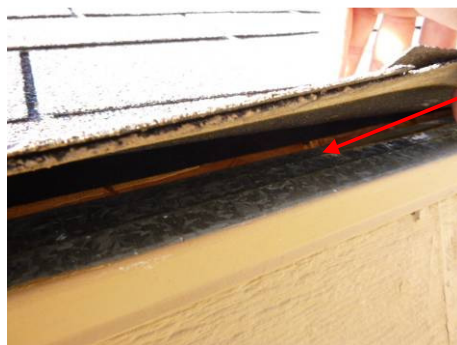
[X] The felt paper underlayment should be installed over the top of the drip edge flashing. Two areas were sampled and south edge of garage the paper is cut short, south side of entry the felt is beneath the drip edge. Nothing much can be done; this is a common mistake.

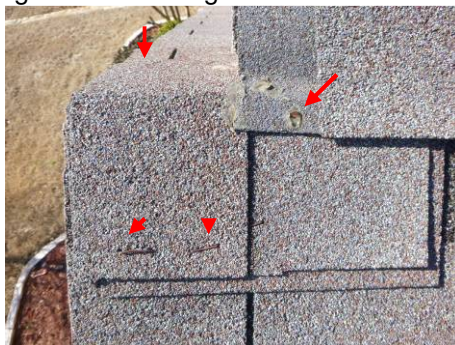
[X] Exposed roofing fasteners along the front elevation shingles should be sealed.

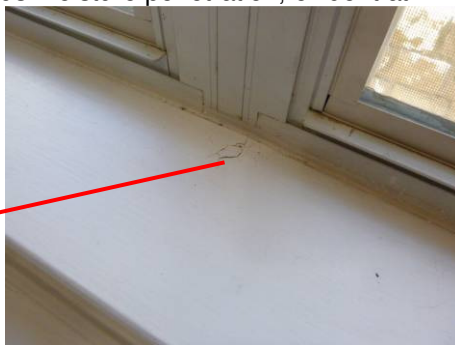
[X] Interior previous moisture penetration, evident at window sills: master bedroom, kitchen nook.

Very little penetration

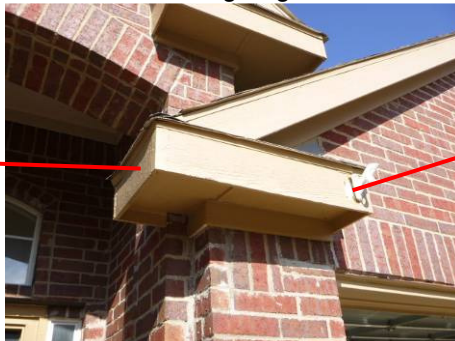
[X] Exterior decay present at base of garage door jamb, fascia boards at the northwest corner of the garage, a few trim boards at the kitchen nook window seat. A few holes where flag base is attached at the fascia NW corner of garage.

decay

holes

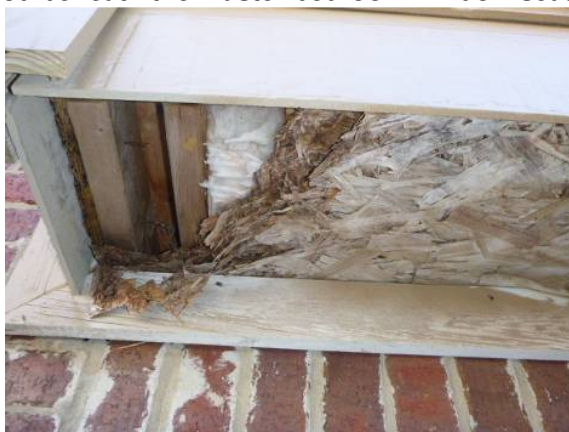
[X] Damaged wood beneath the master bedroom window seat in need of repair.

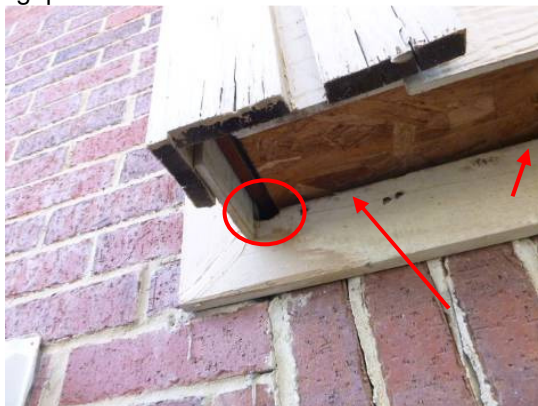
[X] small hole and gap should be sealed beneath the kitchen nook window seat.

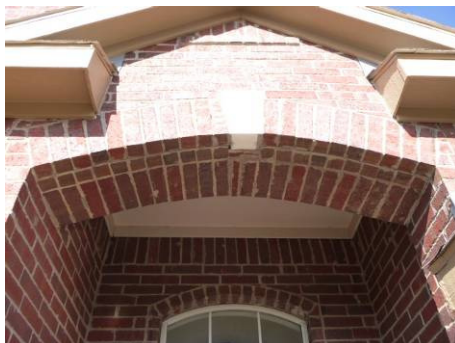
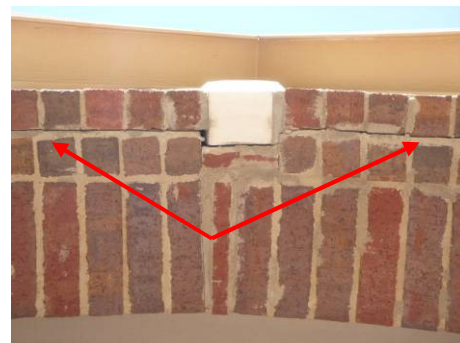
[X] Need to fill gap in mortar beneath the entry arch. . . some minor prior patch and silicone at the entry cover.

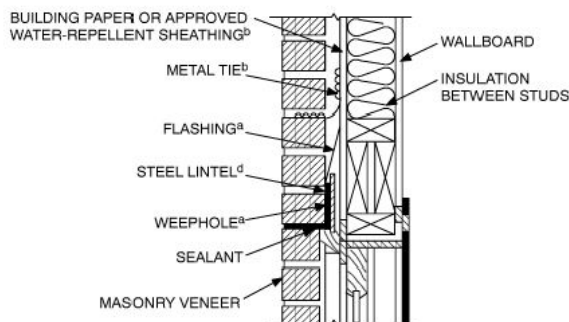
[X] Exterior Missing weep holes over steel lintels above windows, doors, garage door(s) where there is masonry above [IRC code effective 2003].

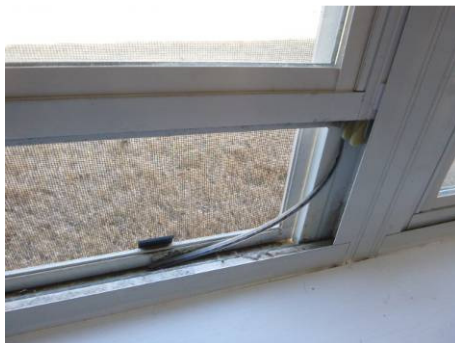
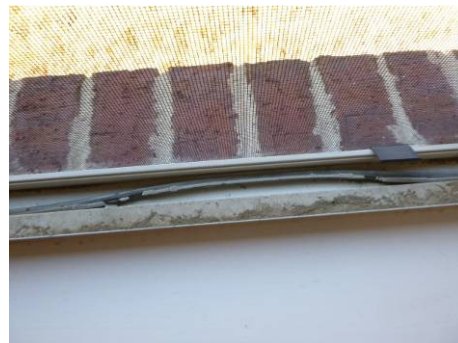
Defective double pane windows (broken seal or hazy or condensation between the glass panels) at: living room 1, master bedroom 1, NW bedroom 1, Window glazing is marked with a **black** penned **X** and/or **Orange Stickers**.

Loose insulation master bedroom north window and loose insulation at the NW bedroom window.

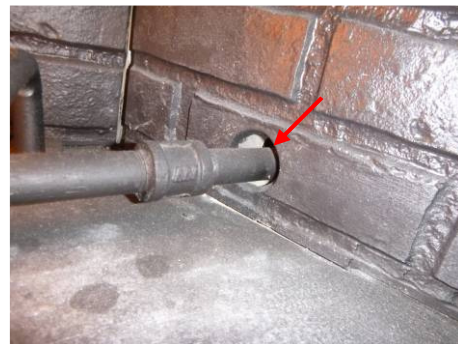
[X] Seal gas line penetration through side wall of firebox with fireclay. Similar photo – same condition.

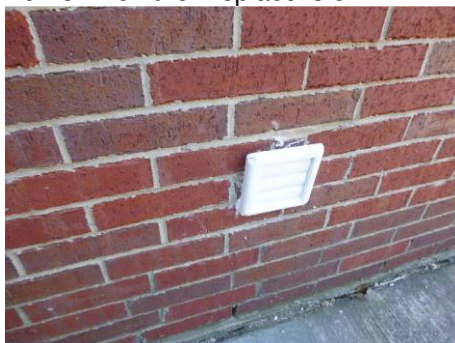
[X] Improper combustion make-up air vent at the exterior of the chimney. This should be a screened opening with a hood to prevent rain intrusion. Purpose is that it helps draw air into a tightly sealed home when the fireplace is on.

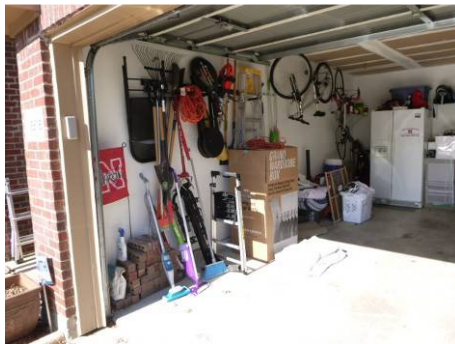
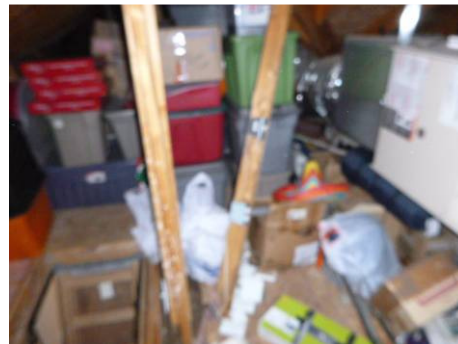
Storage items can obstruct the inspector's view or access to some areas i.e. garage left, attic right

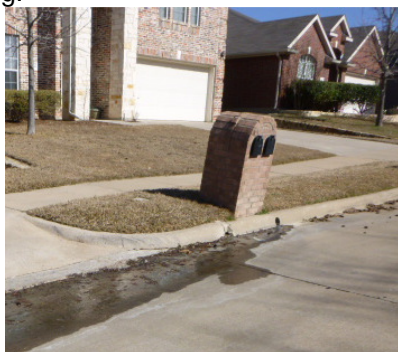
Mail box is leaning.

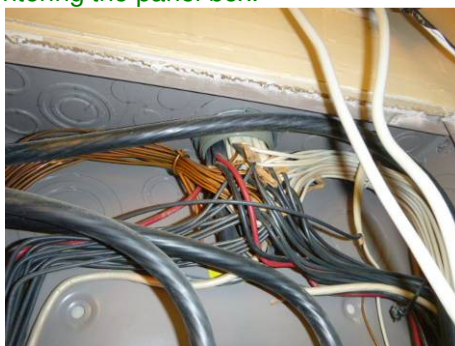
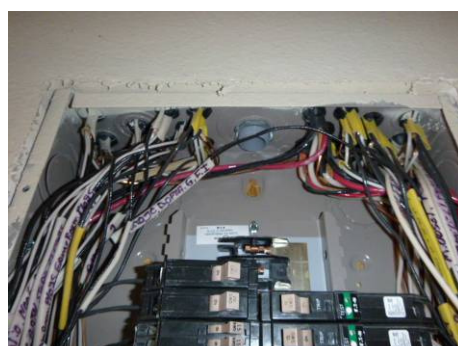
[X] It has been a building practice for along time the wires entering the panel box will be separated (spread out) and attached secured with cable clamps instead of feeding all the wires in through one tight opening. Only in very recent years has the building department enforced this building practice. The photos are not of this home but are similar to the condition at this property. Left photo matches the property inspection and the right is the current practice of separating the wires/or circuits entering the panel box.

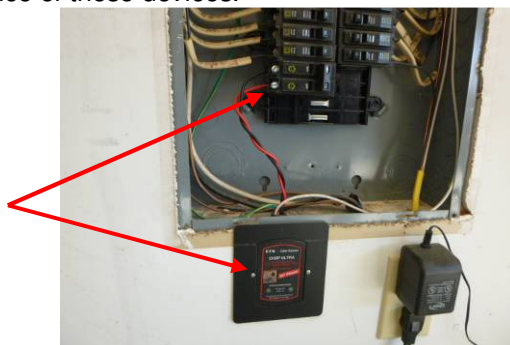
NOTE - There is a surge protector associated with the main panel – I do not inspect the operation or performance of these devices.

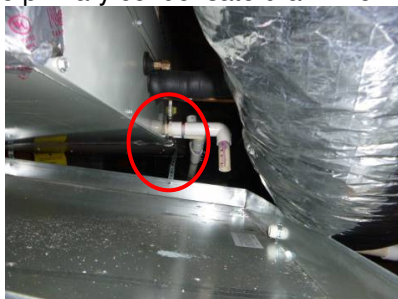
Condensate Drains: [X] The primary condensate drain lines are not equipped with a p-trap. Under current mechanical installation standards, the manufacturer requires a p-trap be installed in the primary condensate drain line within 6-inches of the coil housing.

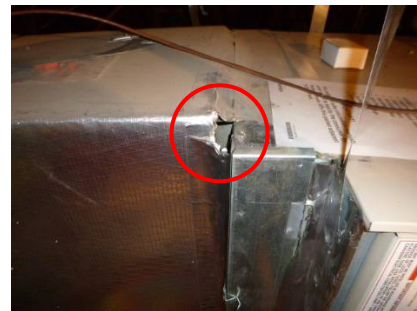
[X] Return air connection to the filter container needs to be sealed.

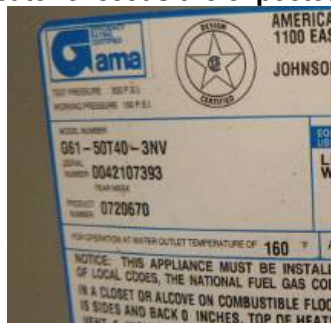
Energy Sources: Gas / Capacity: 1, 50 gal. / Location: Garage / MFG. 2000

The water heater exceeds the expected 10 year life.

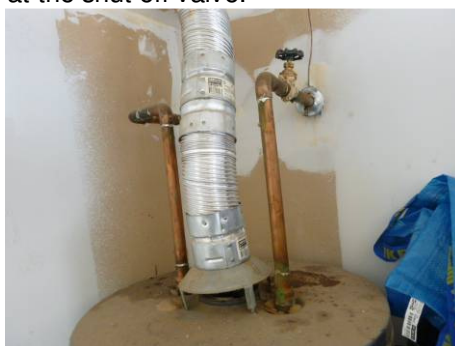
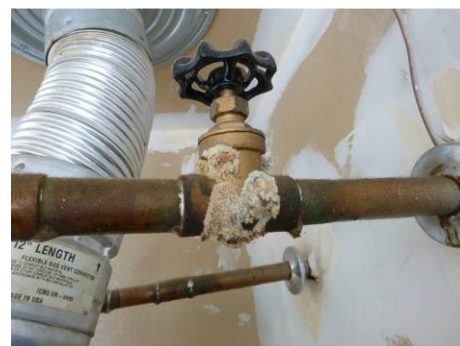
[X] Corrosion at the shut off valve.
